Manhole Inspection Summary

Manhole # S19KK_037MH

Insp Date: **6/4/07 9:06 AM**

Location Address: **2202 SMALLWOOD ST**

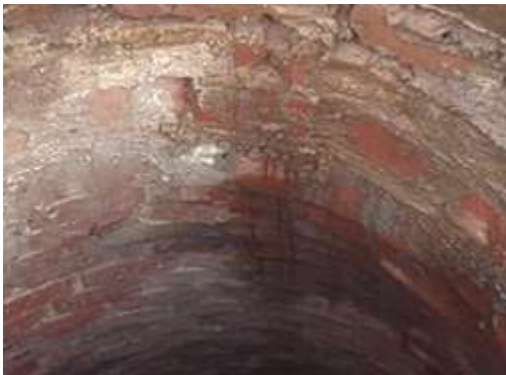
Defect 3

Infiltration: ☐ None ☐ Joint ☐ Cracks ☐ Mortar ☐ Roots ☒ **Wall**

INFILTRATION OF CHIMNEY WALL

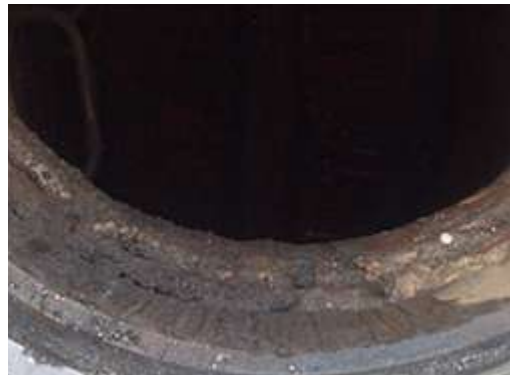
Defect 2

Frame Offset: **1** (in.) Condition: ☒ Sound ☐ Cracked ☐ Leaks

FRAME OFFSET

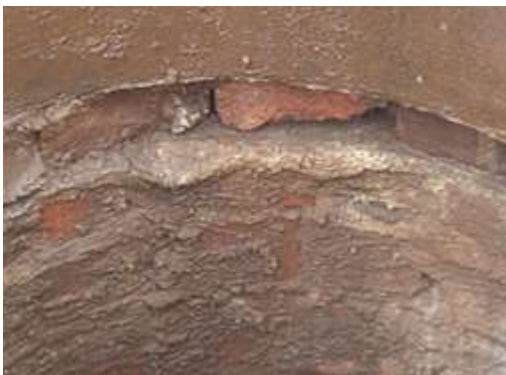
Defect 1

Condition: ☐ Sound ☐ Cracked ☐ Root Intrusion ☐ Loose Brick ☒ **Deteriorated**

DETERIORATION OF CHIMNEY

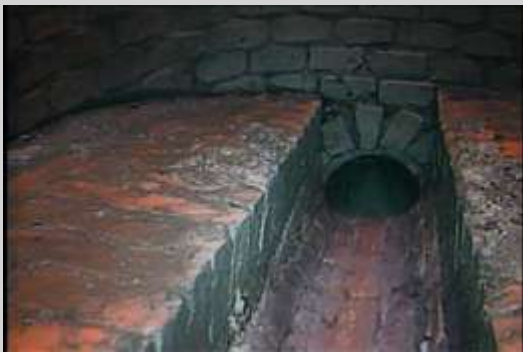
12 O'Clock Outflow

DETERIORATION OF CHIMNEY

Pipe Height: **7.2** (in.) Rod and Bar (Angled)
Pipe Material: **Clay** ☐ Pipe Lined
Invert Depth: **12.43** (ft.) Flow Characteristics: **Fast**
Deposits: ☒ None ☐ Mud ☐ Sludge ☐ Debris ☐ Grease
Silt Depth: (in.) Deposits Extent:
Infiltration: **None** Pipe Seal Cond: **Cracked**

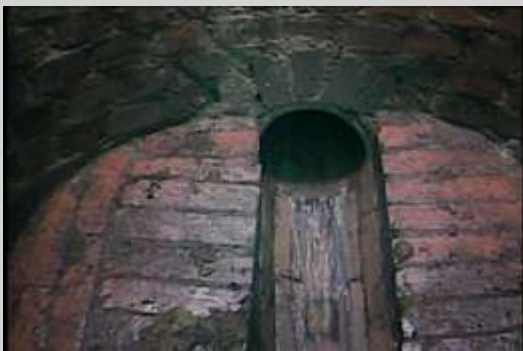
6 O'Clock Inflow

Pipe Height: **8.4** (in.) Rod and Bar (Angled)
Pipe Material: **Clay** ☐ Pipe Lined
Invert Depth: **11.11** (ft.) Flow Characteristics: **Fast**
Deposits: ☒ None ☐ Mud ☐ Sludge ☐ Debris ☐ Grease
Silt Depth: (in.) Deposits Extent:
Infiltration: **None** Pipe Seal Cond: **Sound**
